**RESEARCH AND APPLICATION ENGINEERING TO
DETERMINE THE EFFECT OF PROCESSING VARIABLES
ON CRACK PROPAGATION OF HIGH-STRENGTH
STEELS AND TITANIUM**

TECHNICAL DOCUMENTARY REPORT NO. ASD-TDR-62-1034, PART I

April 1963

(Prepared under Contract No. AF33(616)-8156 by the Crucible Steel
Company of America, Pittsburgh, Pennsylvania; B. R. Banerjee
and J. J. Hauser, authors.)

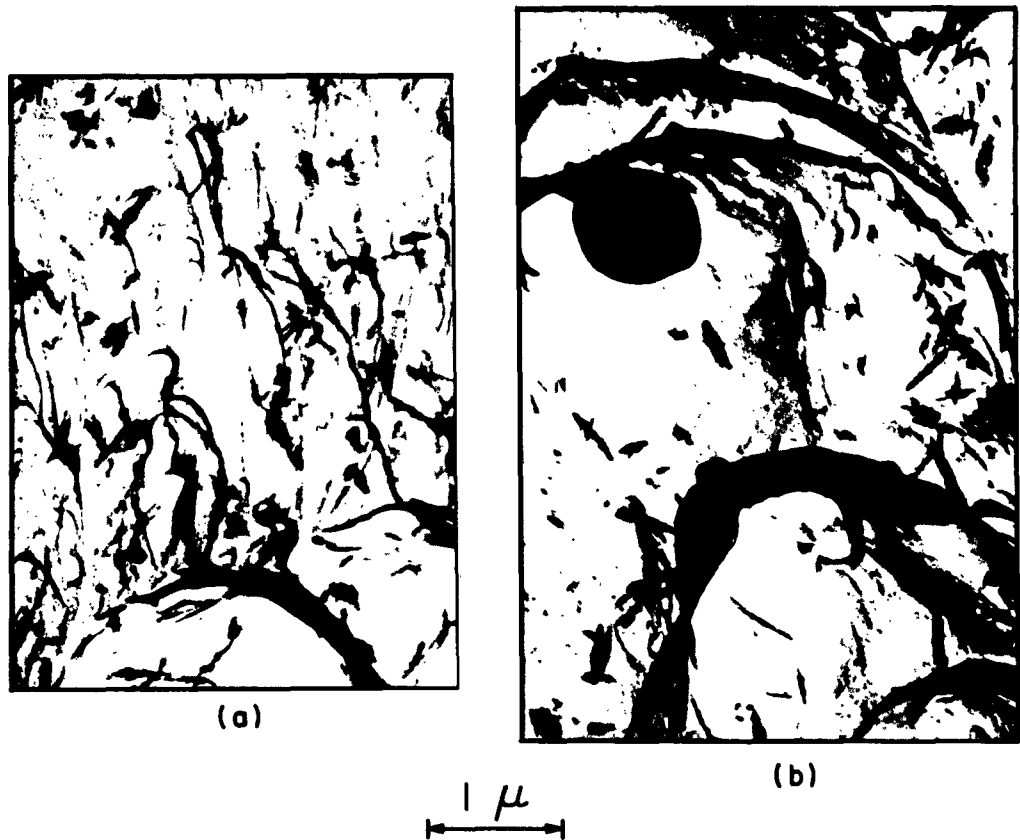
Figure 6

Structural Details within Parabolic Dimples as seen
in Etch - Shadow Extraction Replicas

Note parabolic fractures nucleated by precipitated
particles and by an inclusion.

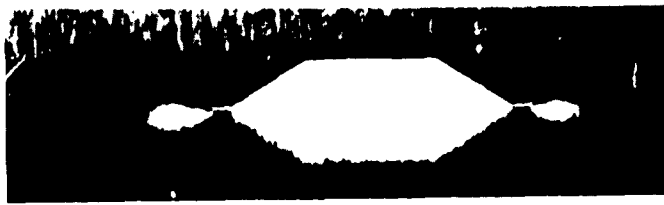
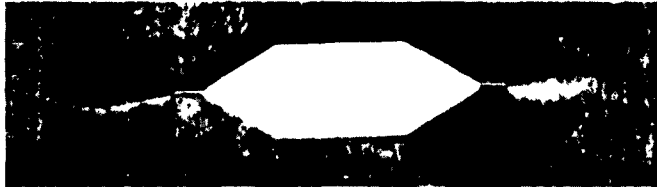
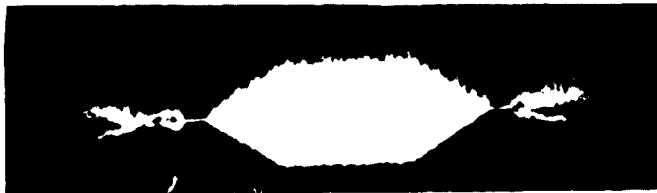
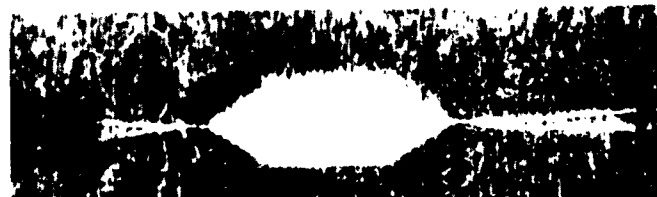
Figure 8

(a) Specimen 10B20
 $K_{CI} = 205,000 \text{ psi } \sqrt{\text{in.}}$

(b) Specimen 23L19
 $K_{CI} = 160,000 \text{ psi } \sqrt{\text{in.}}$

(c) Specimen 23K21
 $K_{CI} = 151,000 \text{ psi } \sqrt{\text{in.}}$

(e) Specimen 23G13
 $K_{CI} = 100,000 \text{ psi } \sqrt{\text{in.}}$

Movie Frames Just Prior to Onset of Rapid Crack Propagation
 in 4340 Centrally Notched Samples

Note extent of cracks and occasional asymmetry; forked appearance represent localized deformation in the plastic zone surrounding the slow crack.

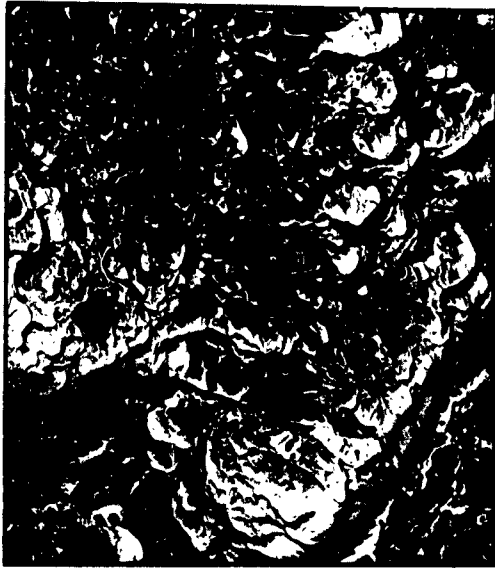
Figure 19

Fracture Surfaces of 4340 Steel at Tensile
Strength of 190,000 psi

Smooth tensile (tempered at 900 F).

The transverse specimen showed a macroscopically flat but fibrous fracture (Figure 15), and the submicrotopograph showed extensive and numerous glide-plane decohesions along with the usual dimples or parabolic fracture paths [Figures 19(c) and 19(d)]. Figure 19(c) illustrates an excellent example of the tongues^{26,27} seen on fracture planes; these are believed to be indications of secondary cracks in the fracture plane where the replica found its way into the crack, creating small laps or tongues projecting from the replica surface. Both figures exhibit regions of severe replica folding caused by the macroscopic transverse fibers.

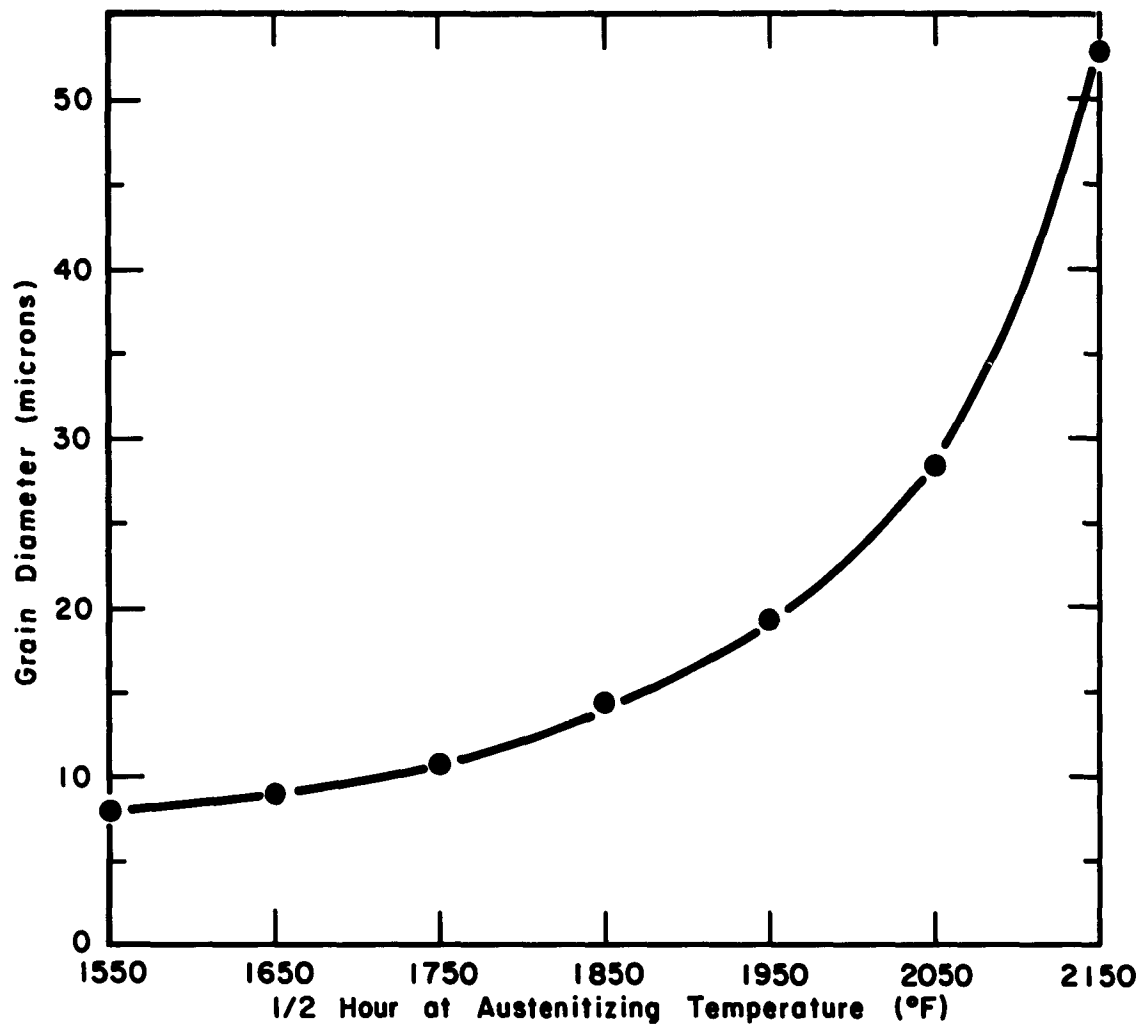
Figure 21

Grain Size of Air - Melted 4340 Steel

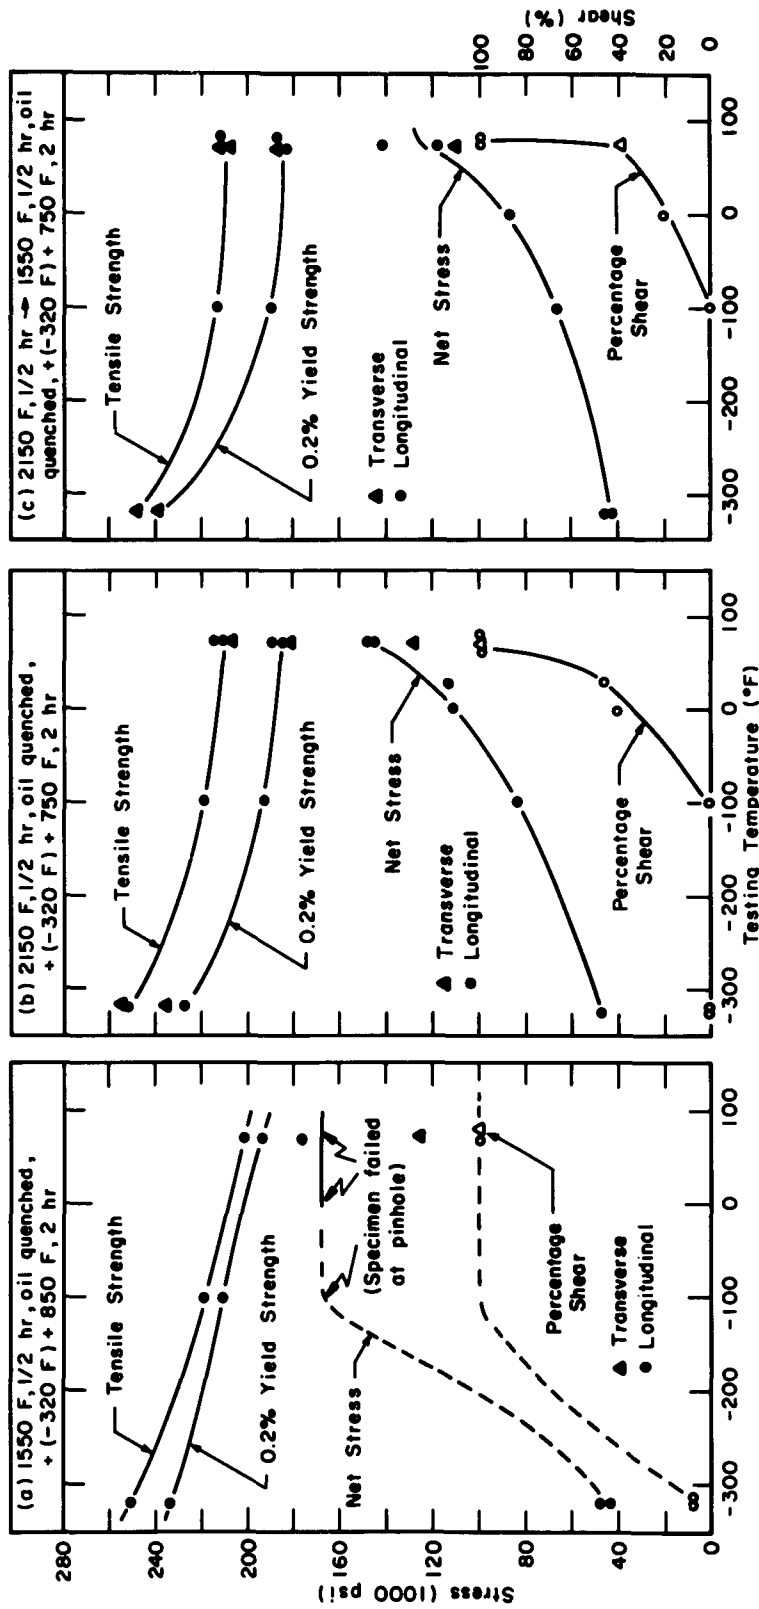
Figure 22

Properties of Air-Melted 4340 Steel (0.067-Inch-Thick Specimens) Given Modified Treatments to Produce a 190,000 psi Yield Strength at Room Temperature

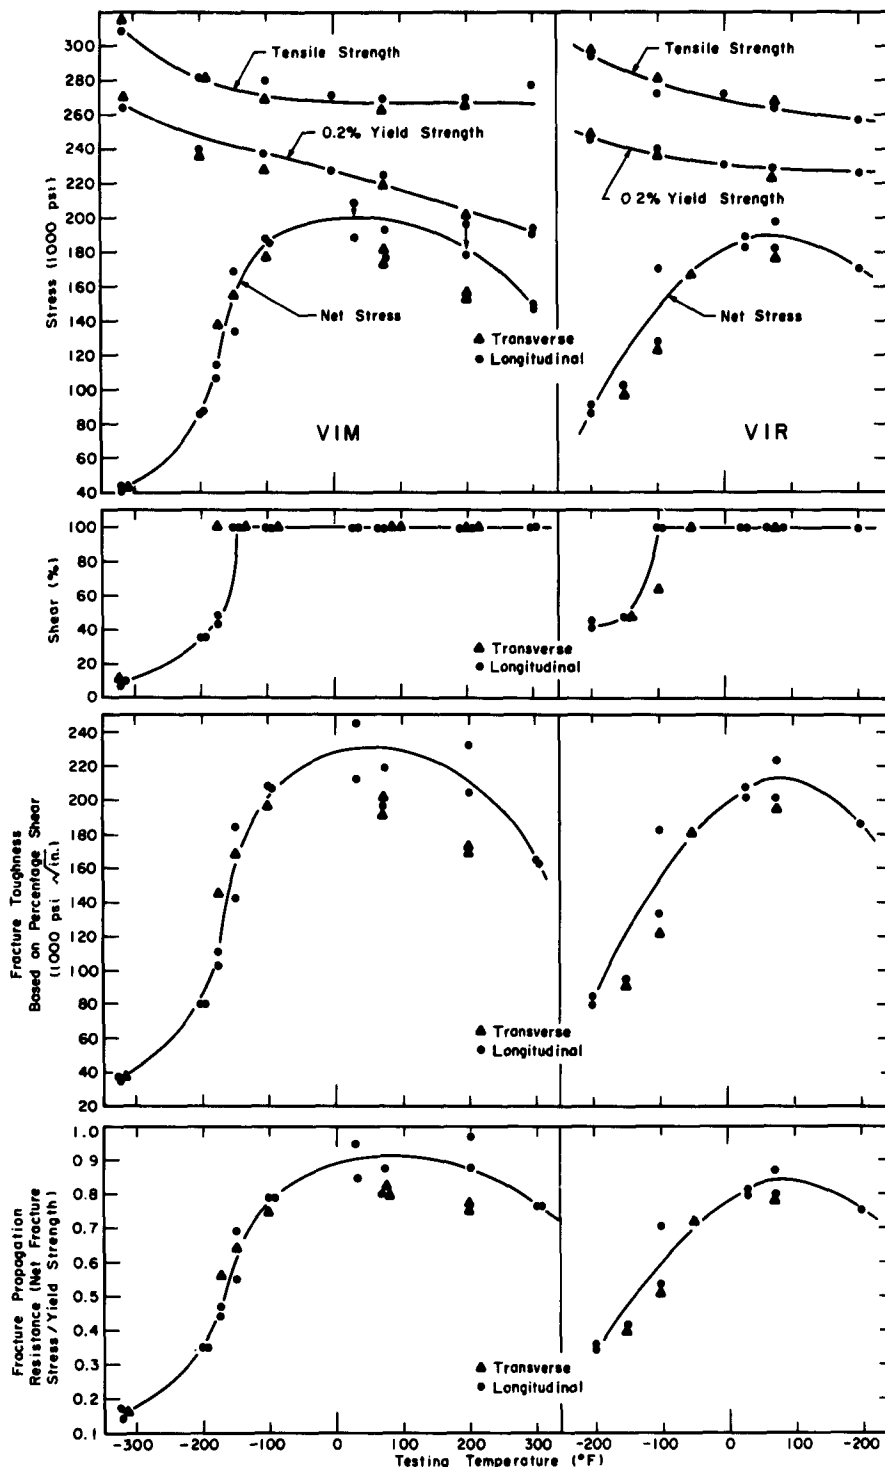
Figure 26

Smooth-Bar Tensile Properties and Notch Strength Properties of Vacuum-Induction-Melted and Vacuum-Induction-Remelted 4340 Steel

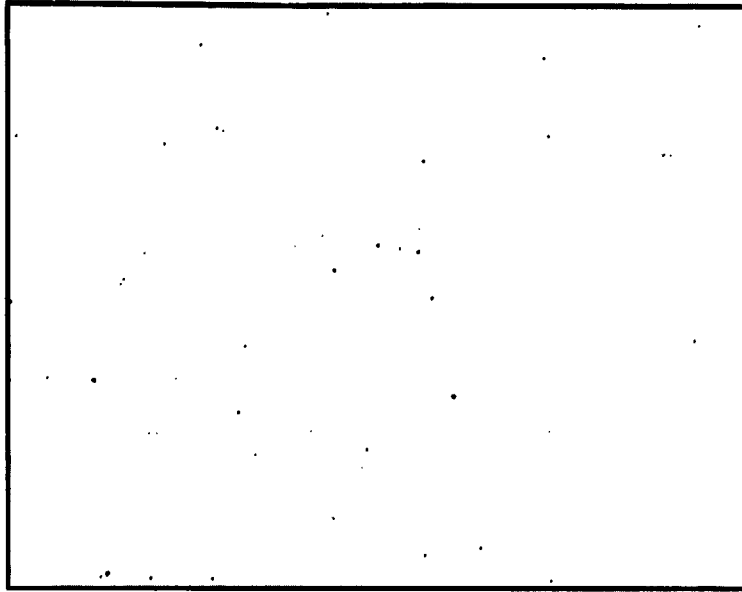
Figure 28

Typical Inclusion Content in Type 422 Stainless Steel (100X)

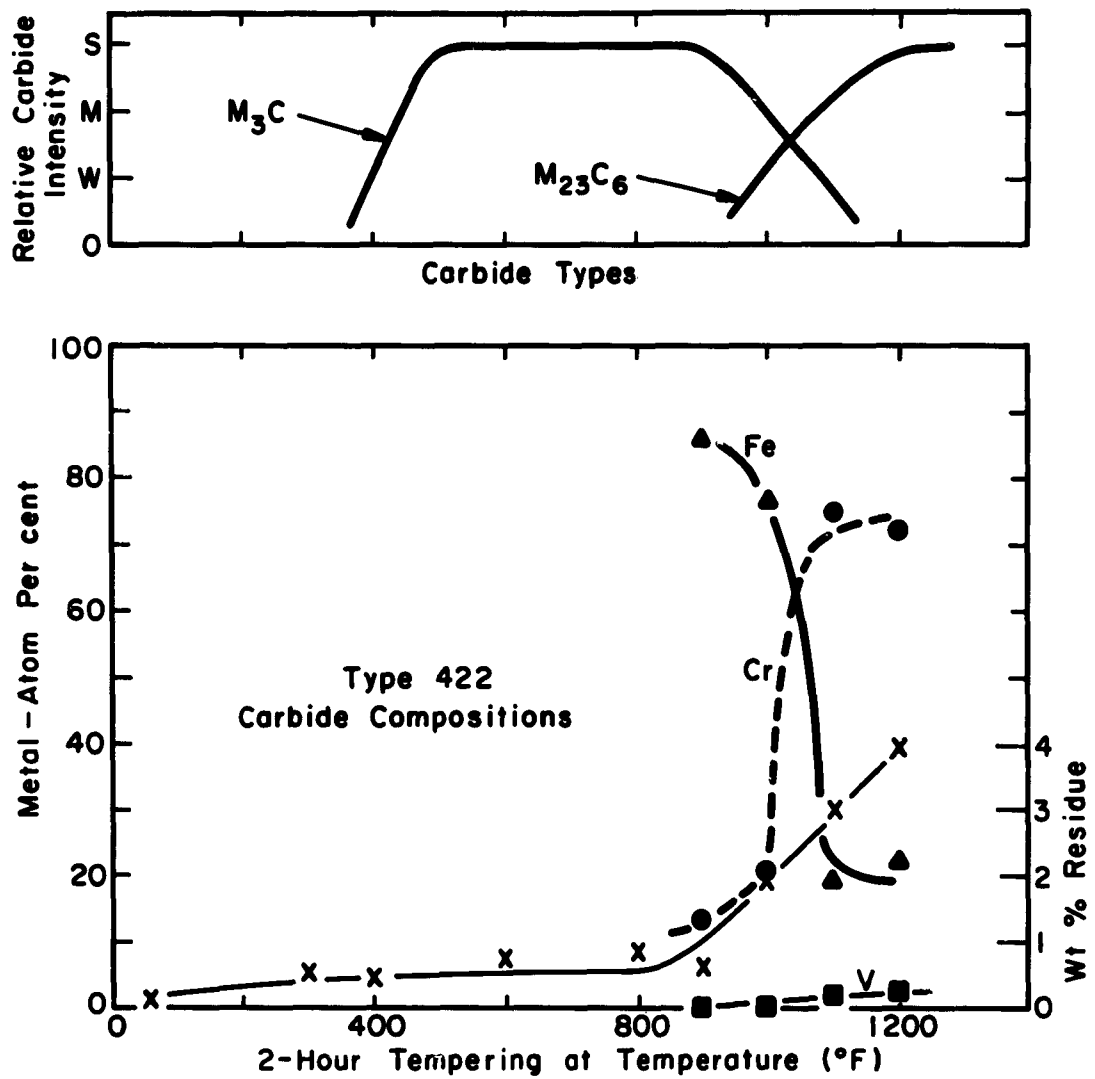
Figure 29

**Carbide Analysis of Type 422 Stainless Steel
as a Function of Tempering Temperature**

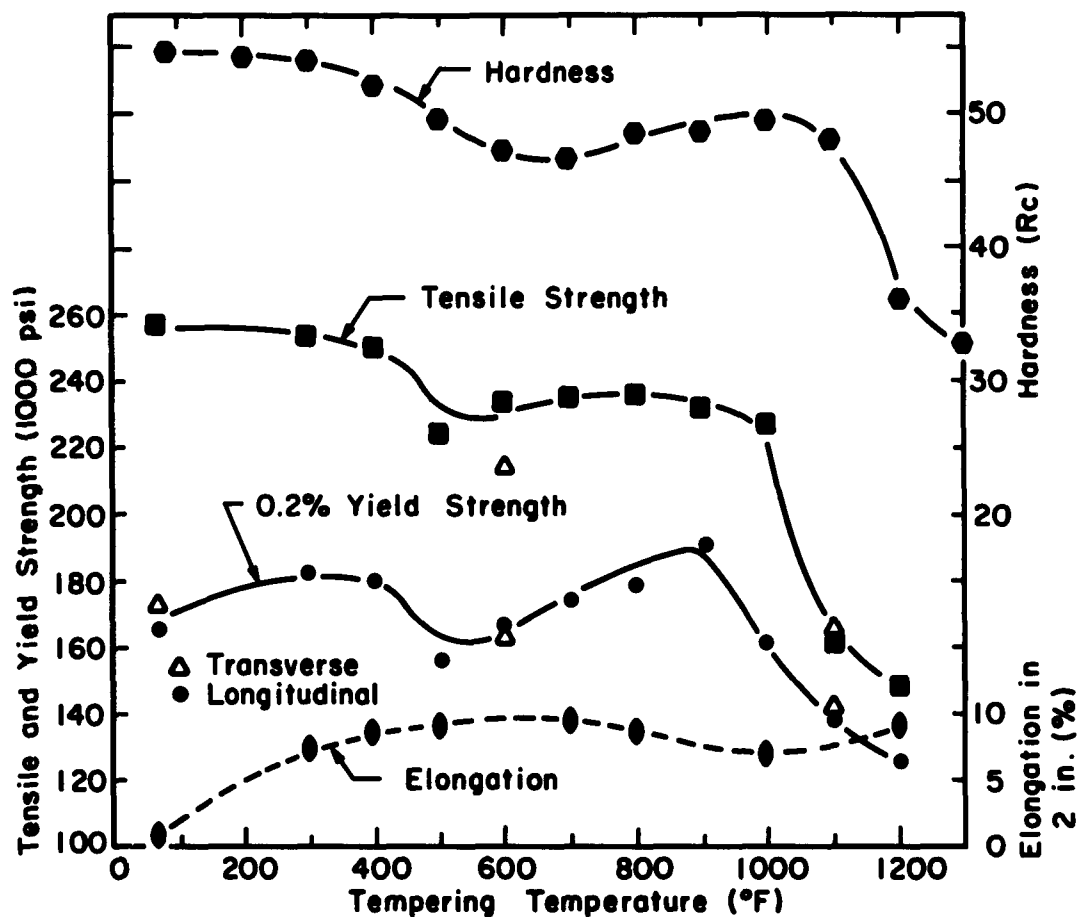
Figure 30

**Hardness and Smooth Bar Tensile Properties of
Tempered Type 422 Stainless**

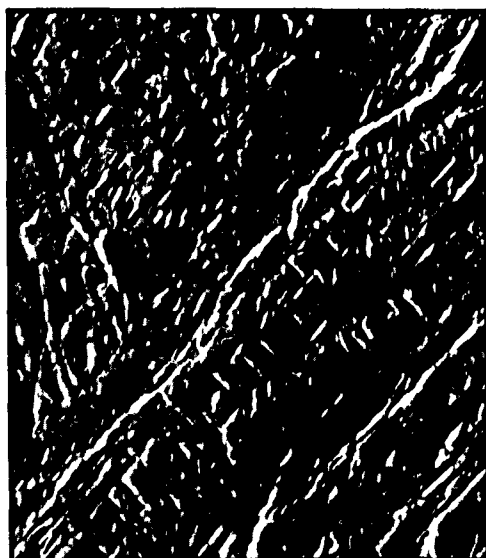
Figure 33

Micrographs of Type 422 Stainless Steel
Tempered at 500 F for 2 Hours

Vilella's Reagent

Tempering at 500 F produces a significant drop in tensile and yield strengths (Figure 30). The replica and transmission micrographs of the 500 F tempered structure (Figure 33) suggest the growth of the M_3C carbide to a maximum length, reaching micron dimensions. The significant coarsening of the M_3C precipitate is

clearly evident in the extraction replica. Thus, the observed dip in the tempering curve (Figure 30) at 500 F may be understood in terms of the pronounced growth in carbide-precipitate size (Figure 33). The surface replica also shows a general smoothening of the matrix, and this is further confirmed by the reappearance of blank, precipitate-free areas in the extraction replica. The transmission micrographs show dislocation tangles around precipitate particles.

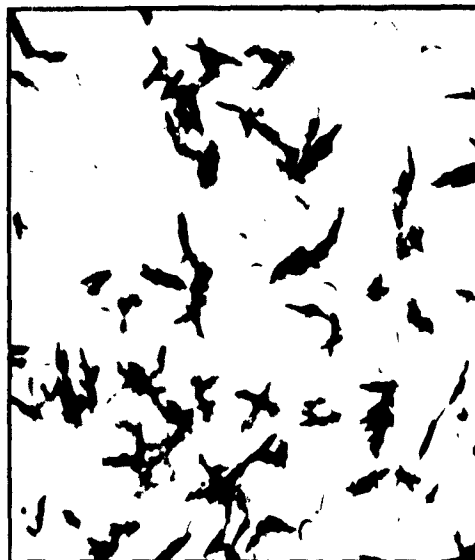
Figure 35

Micrographs of Type 422 Stainless Steel
Tempered at 800 F for 2 Hours

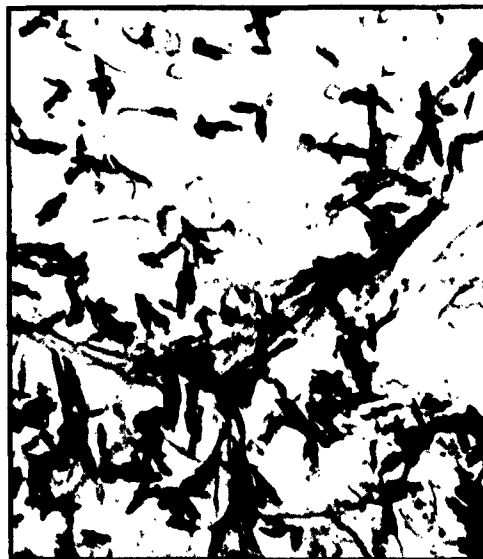
Figure 36

Micrographs of Type 422 Stainless Steel
Tempered at 900 F for 2 Hours

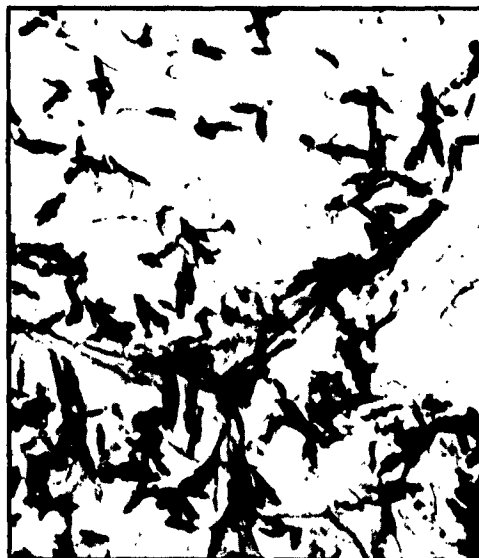
Figure 36

Micrographs of Type 422 Stainless Steel
Tempered at 900 F for 2 Hours

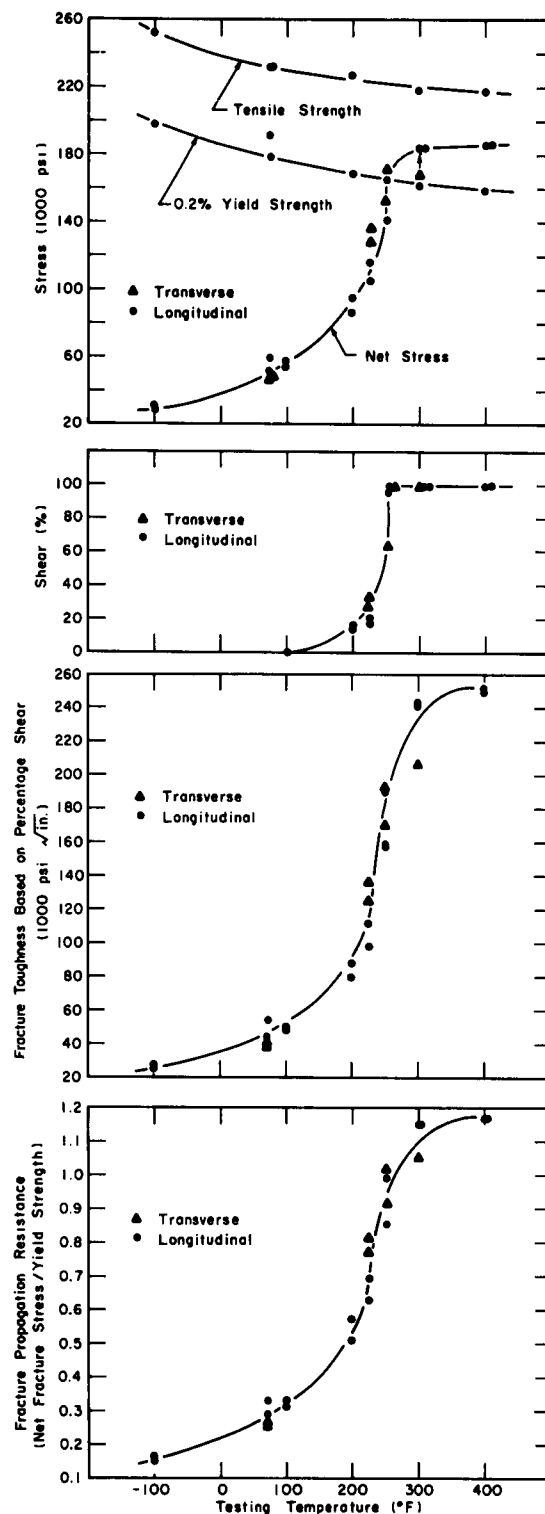
Figure 40

Properties of Type 422 Stainless Steel

0.067 - inch-thick specimens austenitized at 1900 F for 1 hr, oil quenched, refrigerated at -320 F, and tempered at 900 F for 2 hr.

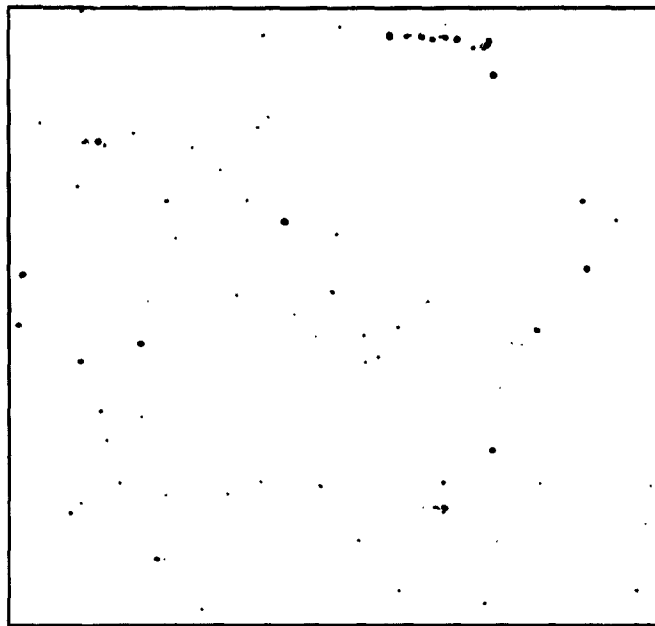
Figure 43

Typical Inclusion Content Observed in Crucible 218 (100X)

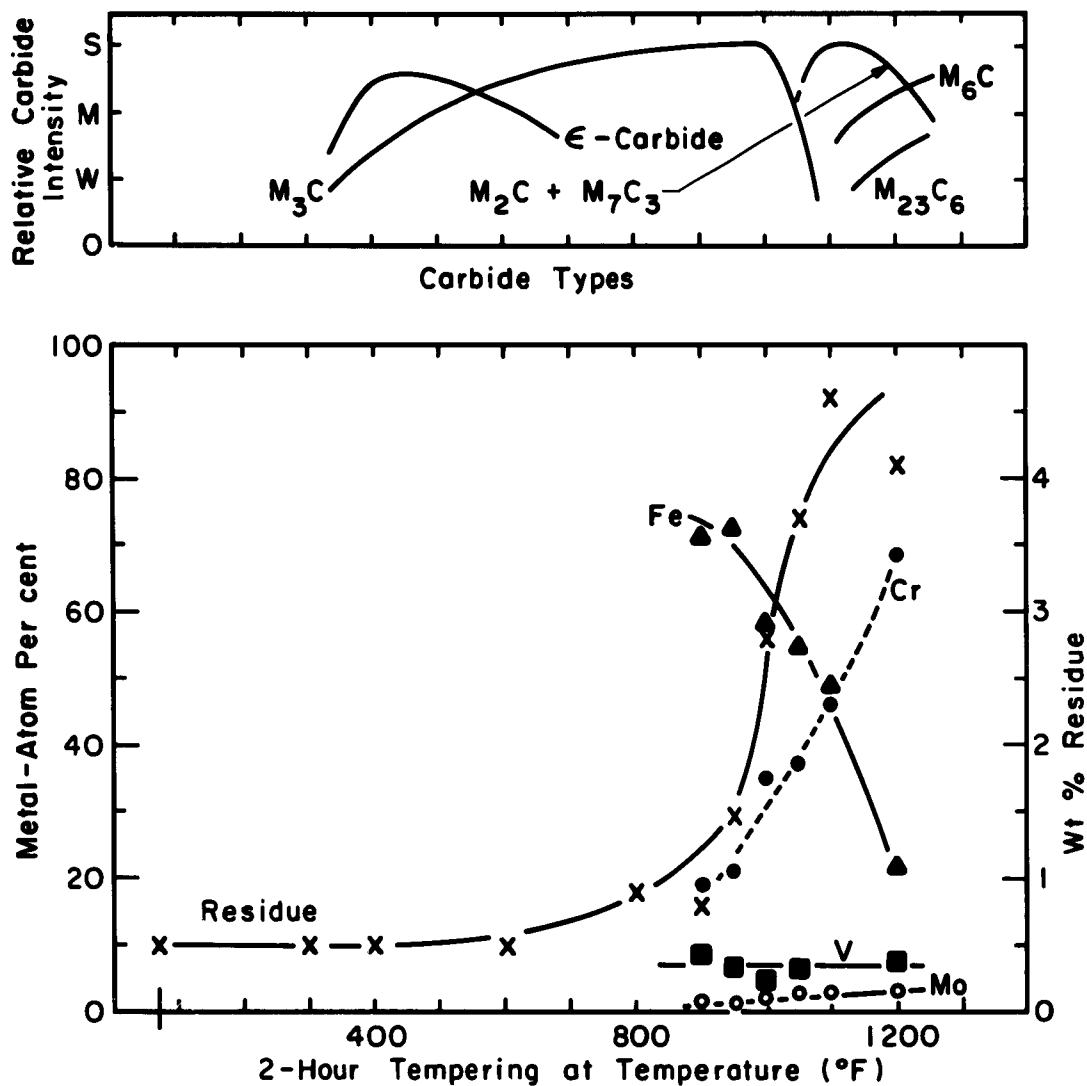
Figure 44

Carbide Analyses of Crucible 218 as a Function of Tempering

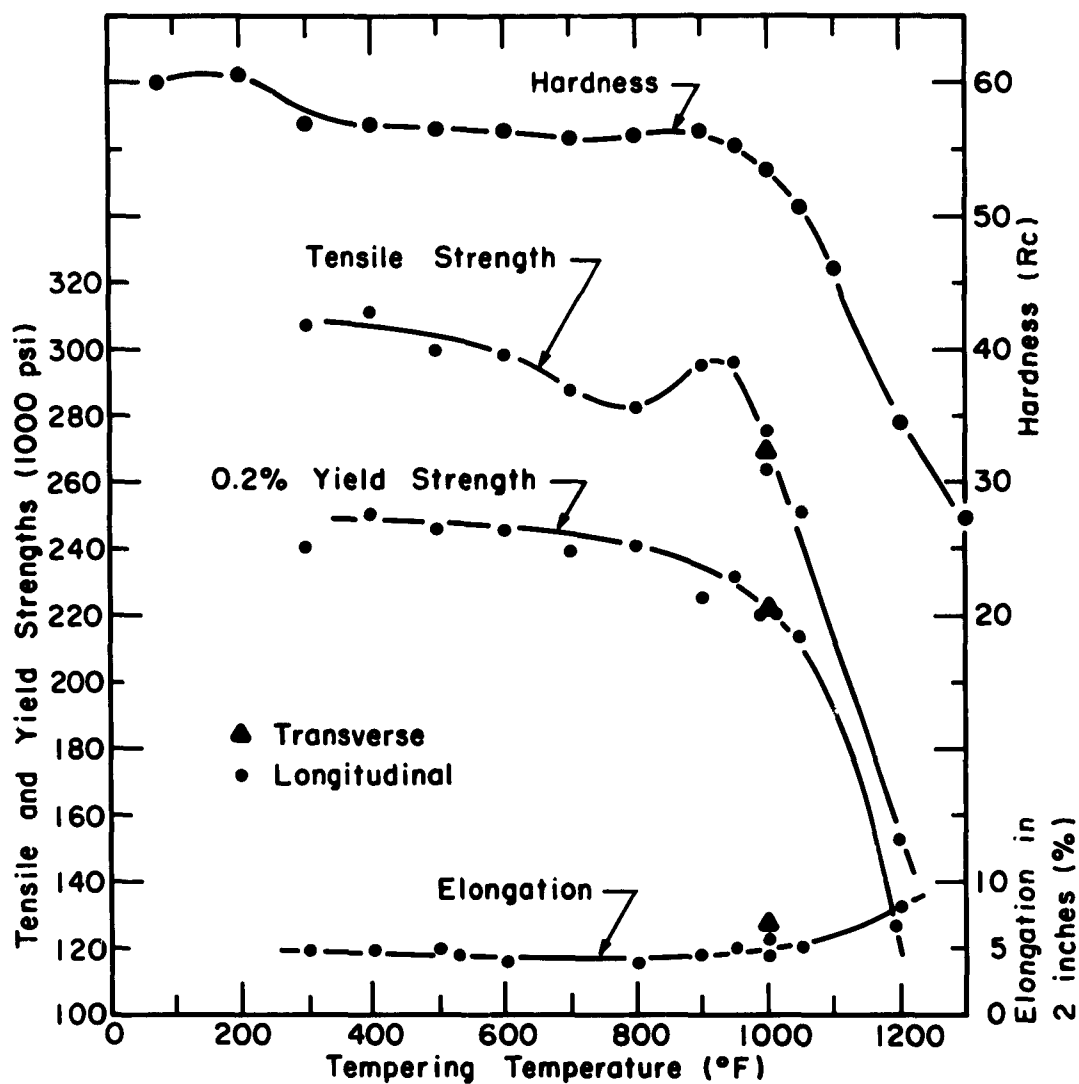
Figure 45

**Effects of Tempering on Hardness and Tensile Properties of Crucible 218
Tempered at Indicated Temperature for 2 + 2 Hours**

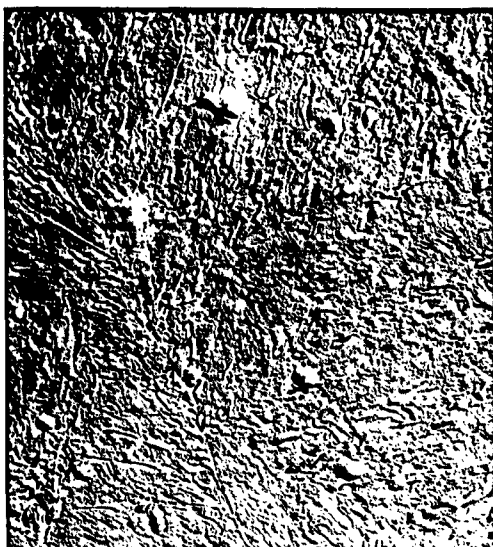
Figure 50

(a) Surface Replica (15,000X)

(b) Extraction Replica (30,000X)

(c) Thin Section (30,000X)

(d) Thin Section (60,000X)

The surface replica micrograph (Figure 50) of the 900 F tempered structure suggests a finer precipitate size than was seen at 800 F (Figure 49), and the extraction replica tends to support this observation because of many more small particles in addition to the previously observed platy precipitates. These observations suggest a new precipitation of perhaps an alloy carbide at these temperatures. Diffraction data mark

A fine general precipitation, accelerated at intermartensite boundaries, is also suggested in the transmission micrograph (Figure 50) at 30,000X. At 60,000X, preferred nucleation of fine precipitates at dislocation nodes and lines is clearly seen; some of the previously observed large platy precipitates may also be seen in this micrograph. The observed increase in tensile strength (Figure 45) of 280,000 psi at 800 F to almost 300,000 psi at 900 F tempering is related to this precipitation strengthening although the insensitivity of the yield strength to this structural change is not yet explained.

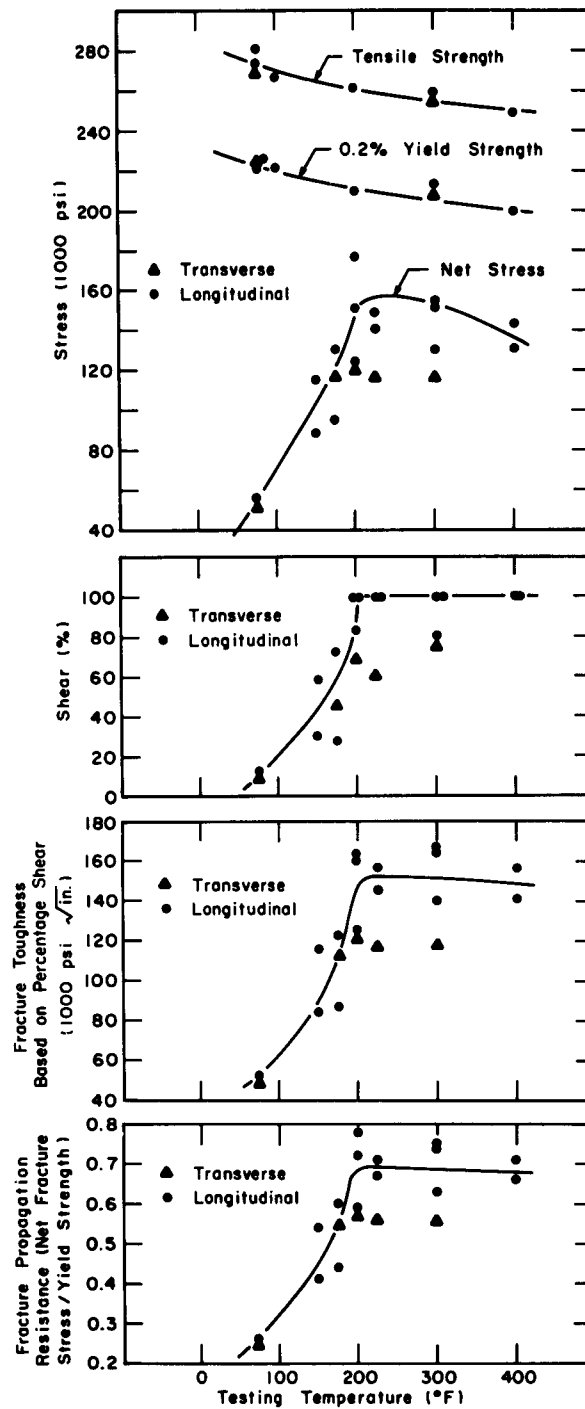
Figure 54

Properties of Air-Melted Crucible 218

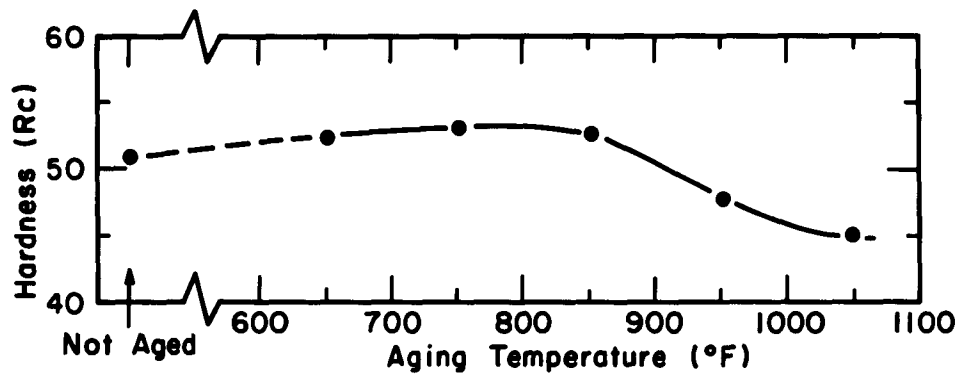
Figure 58

Hardness of Type 301 Stainless Steel Cold-Rolled 67% and
Aged at Indicated Temperature for 8 Hours

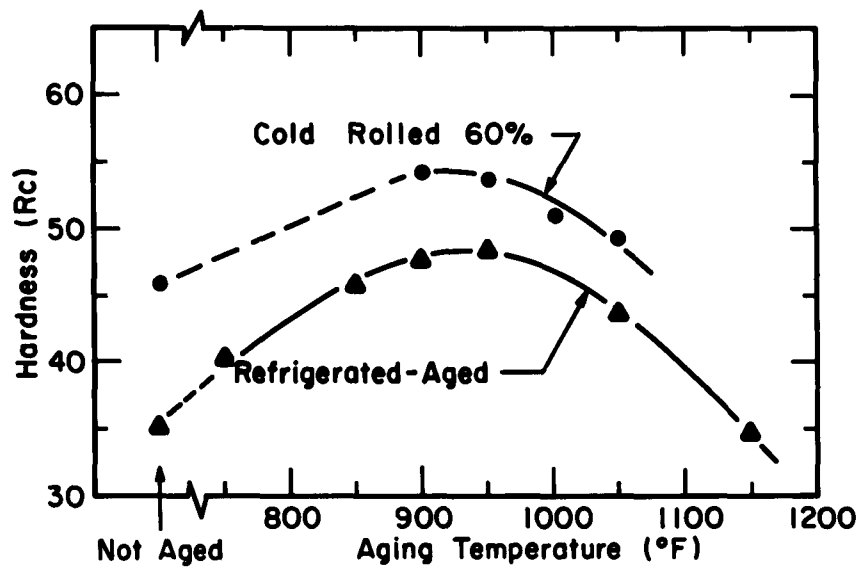
Figure 67

Hardness of PH15-7Mo Stainless Steel after Aging at Indicated Temperature for 1 Hour (Initially Given a 60% Reduction or Refrigeration - Aging Treatment)

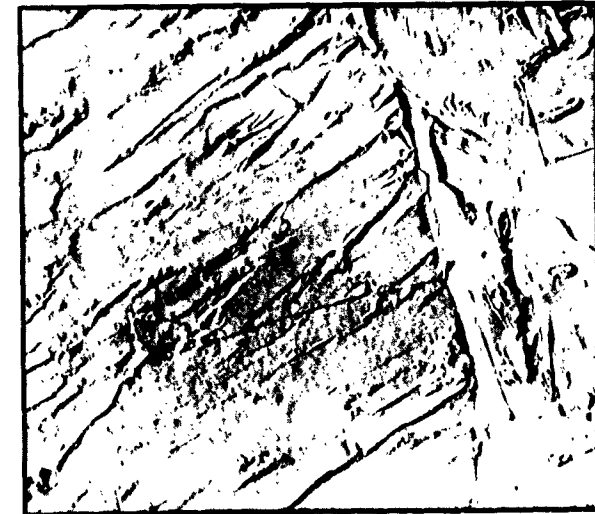
Figure 68

Microstructures of PH15-7Mo Stainless Steel in the Refrigerated and Aged Condition
